## HISTORIC RESOURCES INVENTORY

Common name:						
2.	Historic name: _			·			
3.	Street or rural ac	ddress:	7453	Monterey	Street	21.	
	City Gilro	ıy		Zip	95020	County_Sant	ca Clara
4.	Parcel number:	7990	<u> </u>				
5.	Present Owner:	Bonnie Brown				Address: <u>799</u>	Claremont Dr.
	City Morgan	Hill, CA		Zip <u>95037</u>	Ownersh	ip is: Public	Private X
6.	Present Use:	Retail/Comme	ercial	Orio	ginal use:	Retail/Commer	cial

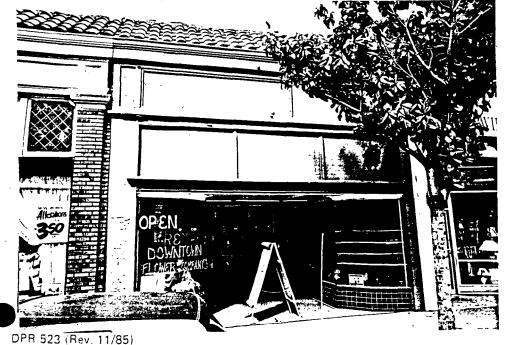
Another well-scaled brick commercial building from the 1920's which has unfortunately been altered by the stuccoing over of the street front commercial window forms. The structure is rectangular in plan. The facade is flat faced with a slightly projected cornice line, a projecting string course, decorative paneling on the upper portion of the street facade. A band of horizontal shaped windows separates the stucco surface from the area that contains the front windows. Note, however, that the existing fenestration is an altered form from the original large plate glass which typifies the commercial style and may be seen unaltered at #7357 next door. The entry is recessed and marked by a simple wooden door which is also an alteration. The major detail element is found in the decorative tile work which frames the lower facade and which is found in slight variations.

13.	Condition: ExcellentGood _AFair Deteriorated No longer in existence
14.	Alterations: Facade Covered in stucco
15.	Surroundings: (Check more than one if necessary) Open landScattered buildings Densely built-up _X Residential Industrial CommercialX. Other:
