HISTORIC RESOURCES INVENTORY

1. Common name: \_\_\_\_\_
2. Historic name: \_\_\_\_\_
3. Street or rural address: 7725 Eigleberry Street  
City Gilroy Zip 95020 County Santa Clara
4. Parcel number: 79900331
5. Present Owner: Louise Weske Address: 7751 Eigleberry S  
City Gilroy Zip 95020 Ownership is: Public \_\_\_\_\_ Private X
6. Present Use: Residence Original use: Residence

- 7a. Architectural style: Early Craftsman
- 7b. Briefly describe the present *physical appearance* of the site or structure and describe any major alterations from its original condition:

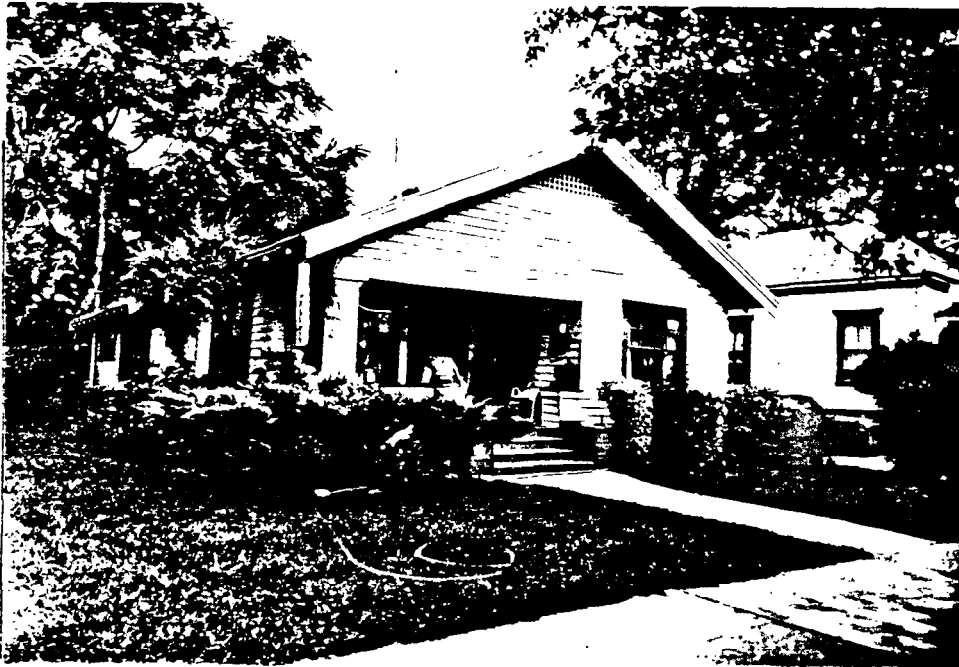
The medium gable is highlighted by some lattice-work decoration at the top of this example of an early craftsman style house. The rafters are exposed at the eaves and there are large, exposed support brackets above the clapboard siding. The recessed porch has square pillars and there is some stained glass in the front door.

13. Condition: Excellent \_\_\_ Good X Fair \_\_\_ Deteriorated \_\_\_ No longer in existence \_\_\_
14. Alterations: \_\_\_\_\_
15. Surroundings: (Check more than one if necessary) Open land \_\_\_ Scattered buildings \_\_\_ Densely built-up X  
Residential X Industrial \_\_\_ Commercial \_\_\_ Other: \_\_\_\_\_
16. Threats to site: None known X Private development \_\_\_ Zoning \_\_\_ Vandalism \_\_\_  
Public Works project \_\_\_ Other: \_\_\_\_\_
17. Is the structure: On its original site? X Moved? \_\_\_ Unknown? \_\_\_
18. Related features: Large trees
