HISTORIC RESOURCES INVENTORY

1. Common name: _____
2. Historic name: _____
3. Street or rural address: 7191 Church Street
 City Gilroy Zip 95020 County Santa Clara
4. Parcel number: 79901001
5. Present Owner: Carl Head Address: 8950 Carlyle Avenue
 City Gilroy Zip 95020 Ownership is: Public _____ Private X
6. Present Use: Residence Original use: Residence

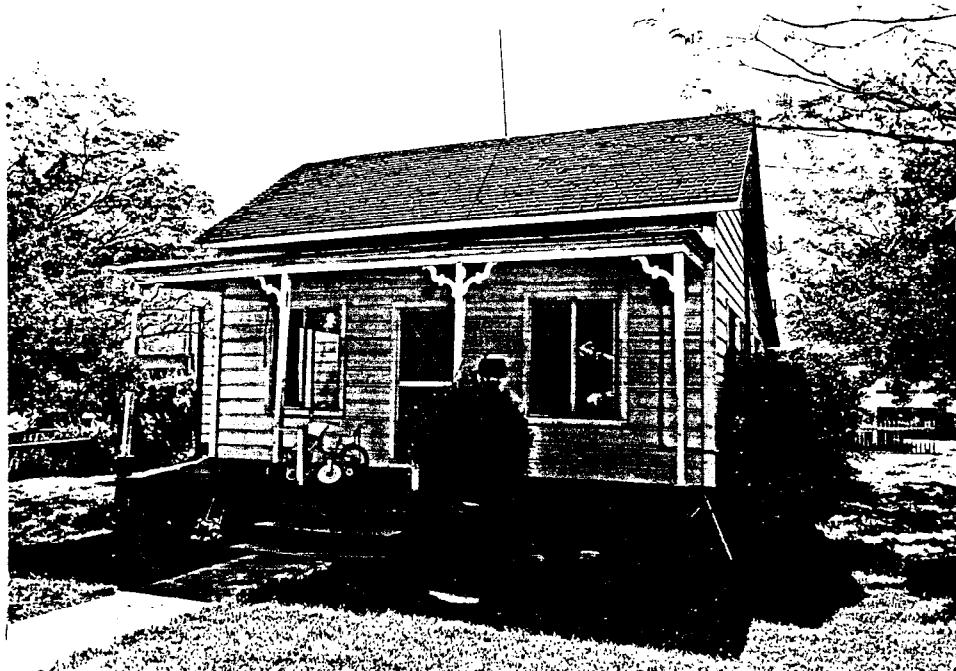
The porch is full width supported by four posts with cut out braces. An early addition to the side has aluminum frame windows. These are the only distinctive changes to the standard side facade pioneer structure. Rectangular in form with a high pitched roof the balance of windows and the central entrance make this a traditional pioneer structure. The structure is sheathed in wide horizontal board with flush joints.
