HISTORIC RESOURCES INVENTORY

1. Common name: _____
2. Historic name: _____
3. Street or rural address: 7401 Monterey Street
 City Gilroy Zip 95020 County Santa Clara
4. Parcel number: 79900765
5. Present Owner: Hall's of Gilroy Address: P.O. Box 606
 City Gilroy Zip 95020 Ownership is: Public _____ Private X
6. Present Use: Clothing Store Original use: commercial

- 7a. Architectural style Stripped Commercial
- 7b. Briefly describe the present physical appearance of the site or structure and describe any major alterations from its original condition:

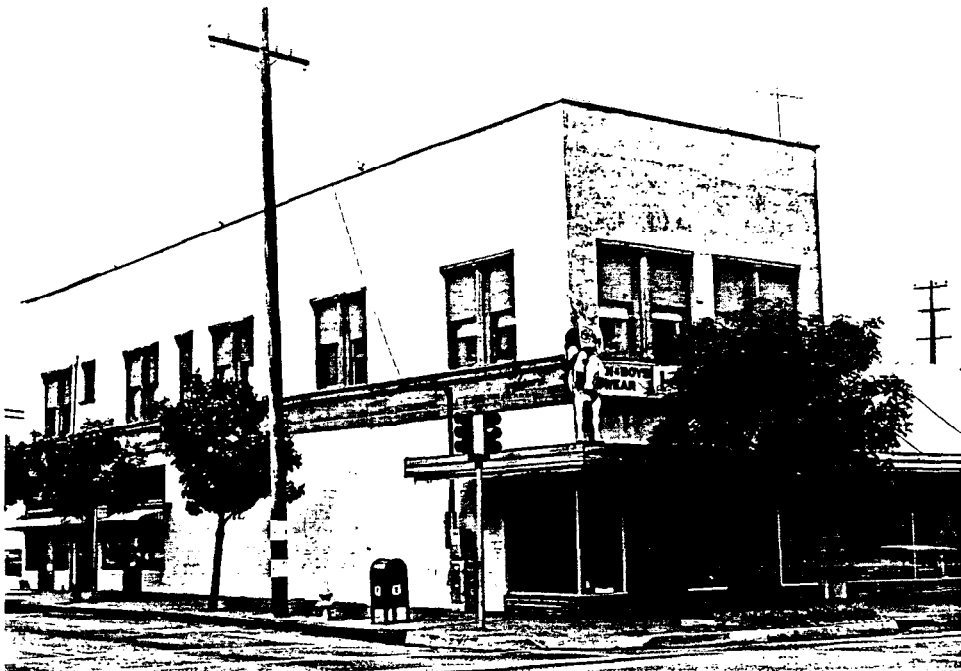
The site contains a tall two story rectangular structure that is stripped and sheathed in stucco. the upper story has a regular pattern of paired double hung windows. The upper window is painted out. Above the window top is a tall band of undecorated stucco that ends at the full height of the parapet. A wide band with molded top encircles the structure below these windows. The storefront is composed of display windows and two recessed doorways, a broad fixed awning extends across the front facade and around the corner onto 6th Street. The focal point of this orderly structure is a full relief horse and rider sculpture that are placed with front hooves down and the horse kicking. This form of advertising art is almost entirely removed from our cities.
