HISTORIC RESOURCES INVENTORY

1. Common name: _____
2. Historic name: _____
3. Street or rural address: 7463 and 7461 Monterey Street
 City Gilroy Zip 95020 County Santa Clara
4. Parcel number: 79900752
5. Present Owner: Andrew Battagin Address: P.O. Box 95
 City Gilroy Zip 95020 Ownership is: Public _____ Private X
6. Present Use: Retail/commercial Original use: retail/commercial

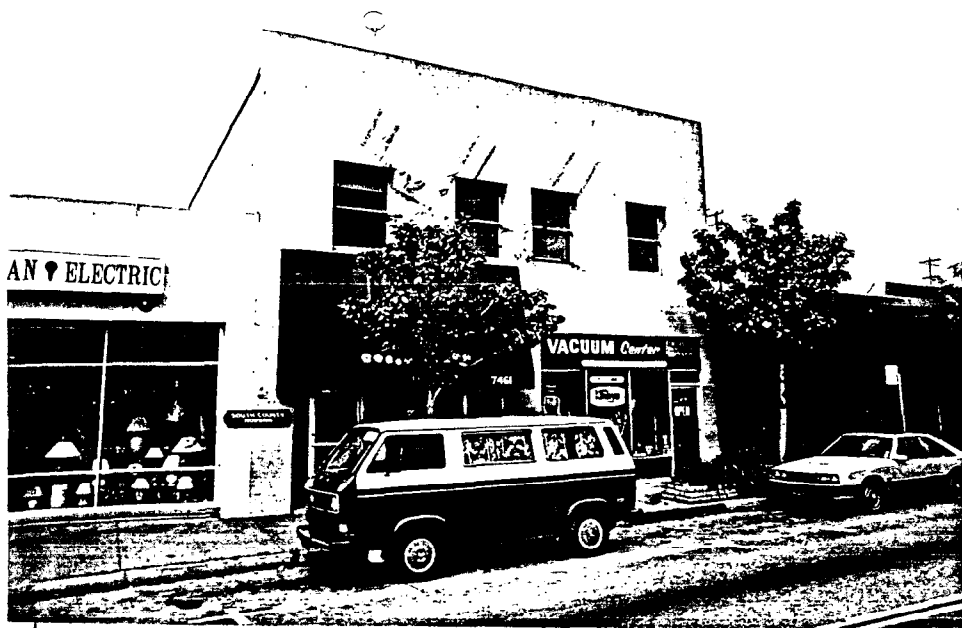
A two and one half story structure that has been stripped of most architectural ornamentation. The upper story has four window openings and the lower squared store fronts that provide a stark geometric pattern all that is present in this building. The storefronts with display windows and recessed entries give this structure the significance of repeating forms with the majority of structures in the Gilroy downtown.

13. Condition: Excellent ___ Good X Fair ___ Deteriorated ___ No longer in existence ___
14. Alterations: stripped plain stucco facade, storefronts modernized
15. Surroundings: (Check more than one if necessary) Open land ___ Scattered buildings ___ Densely built-up X
Residential ___ Industrial ___ Commercial X Other: _____
16. Threats to site: None known X Private development ___ Zoning ___ Vandalism ___
Public Works project ___ Other: _____
17. Is the structure: On its original site? X Moved? ___ Unknown? ___
18. Related features: _____
