HISTORIC RESOURCES INVENTORY

1. Common name: Halls
2. Historic name: _____
3. Street or rural address: 7409 Monterey Street
 City Gilroy Zip 95020 County Santa Clara
4. Parcel number: 79900765
5. Present Owner: George Hall Address: P.O. Box A
 City Gilroy Zip 95020 Ownership is: Public _____ Private X
6. Present Use: Commercial Original use: Commercial

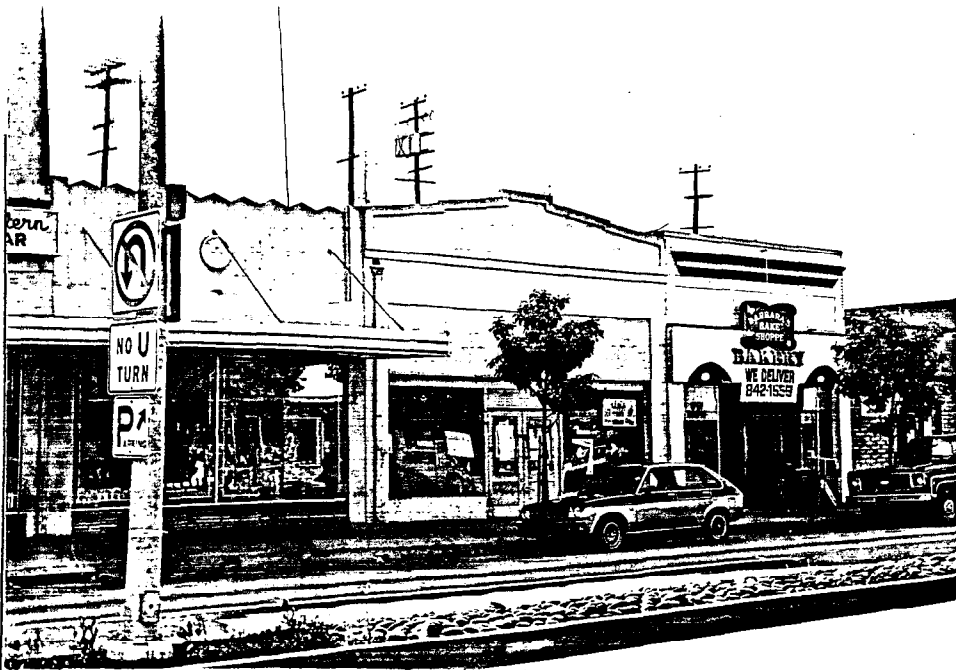
7409 Monterey is a single story structure rectangular in form with a false cornice line of stepped design. A plain recessed panel is above the sign band. Windows were below that and above the awning box. Storefront windows are flat with a central entrance. Incorporated into a single business with the structures to the south, the entry identification has been removed.

13. Condition: Excellent ___ Good X Fair ___ Deteriorated ___ No longer in existence ___
14. Alterations: Facade covered with stucco and paint
15. Surroundings: (Check more than one if necessary) Open land ___ Scattered buildings ___ Densely built-up X
 Residential ___ Industrial ___ Commercial X Other: _____
16. Threats to site: None known X Private development ___ Zoning ___ Vandalism ___
 Public Works project ___ Other: _____
17. Is the structure: On its original site? X Moved? ___ Unknown? ___
18. Related features: Incorporated with structures to the South into 1 busin.
