HISTORIC RESOURCES INVENTORY

1. Common name: _____
2. Historic name: Benevolent Society House
3. Street or rural address: 7429 Alexander Street
City Gilroy Zip 95020 County Santa Clara
4. Parcel number: 841-6-22
5. Present Owner: Rubin Trujillo Address: 7429 Alexander Street
City Gilroy Zip 95020 Ownership is: Public _____ Private X
6. Present Use: Residence Original use: Residence

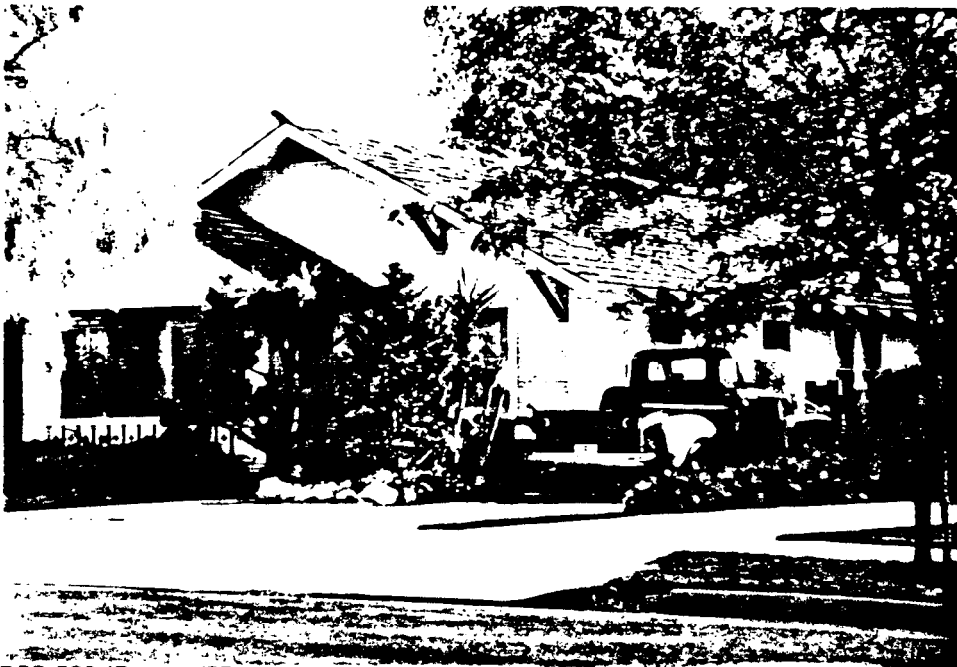
A single story rectangular structure with a double gable facade. The second gable is the roof of the porch and is supported by square piers sheathed in the narrow horizontal board that covers the house. Brackets support the front gable eaves and the porch railing is a cut out board typical of the cost efficient Craftsman design elements. The parcel is enhanced with landscaping very in keeping with the Craftsman movement, low juniper bushes, small pine and desert trees.
