HISTORIC RESOURCES INVENTORY

1. Common name: _____
2. Historic name: _____
3. Street or rural address: 7707 Egleberry Street
City Gilroy Zip 95020 County Santa Clara
4. Parcel number: 79900332
5. Present Owner: John Howorth Address: 7707 Egleberry St
City Gilroy Zip 95020 Ownership is: Public _____ Private X
6. Present Use: Residence Original use: Residence

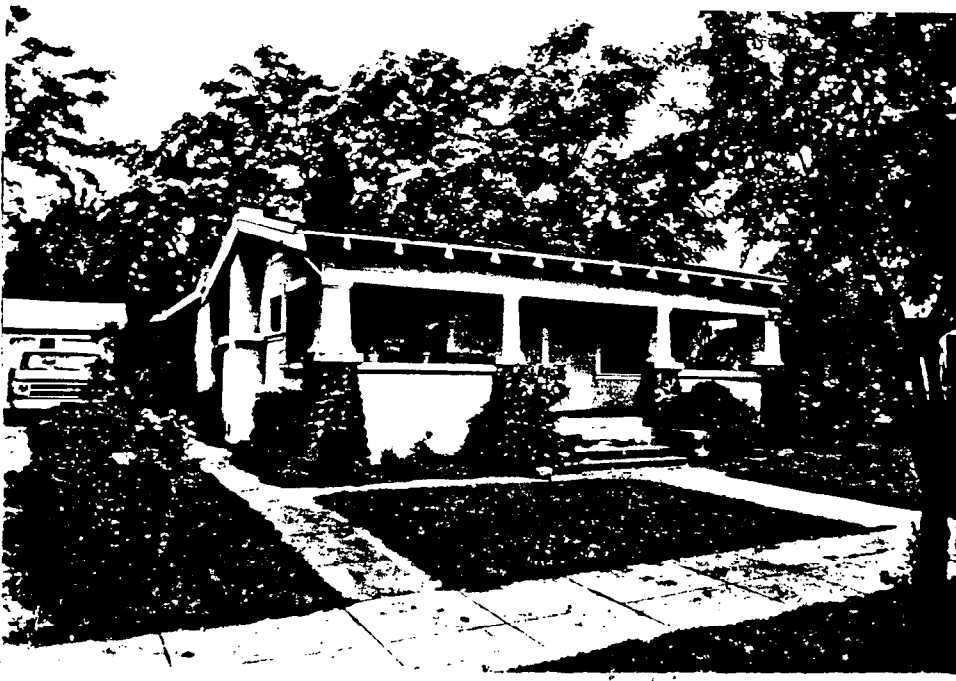
This very low-gabled bungalow has exposed rafters and stucco walls and appears to be sideways version of a combination of craftsman styles. The veranda porch has elephantine columns which rest on bases of cobblestone and shades a pair of front windows decorated with rows of small panes located on top of the larger glass panes.

13. Condition: Excellent ___ Good X Fair ___ Deteriorated ___ No longer in existence ___
14. Alterations: _____
15. Surroundings: (Check more than one if necessary) Open land ___ Scattered buildings ___ Densely built-up X
Residential X Industrial ___ Commercial ___ Other: _____
16. Threats to site: None known X Private development ___ Zoning ___ Vandalism ___
Public Works project ___ Other: _____
17. Is the structure: On its original site? X Moved? ___ Unknown? ___
18. Related features: Mature trees
