HISTORIC RESOURCES INVENTORY

- 1. Common name: _____
- 2. Historic name: _____
- 3. Street or rural address: 7737 Egleberry Street
City Gilroy Zip 95020 County Santa Clara
- 4. Parcel number: 79900330
- 5. Present Owner: Louise Weske Address: 7751 Egleberry St
City Gilroy Zip 95020 Ownership is: Public _____ Private _____
- 6. Present Use: Residence Original use: Residence

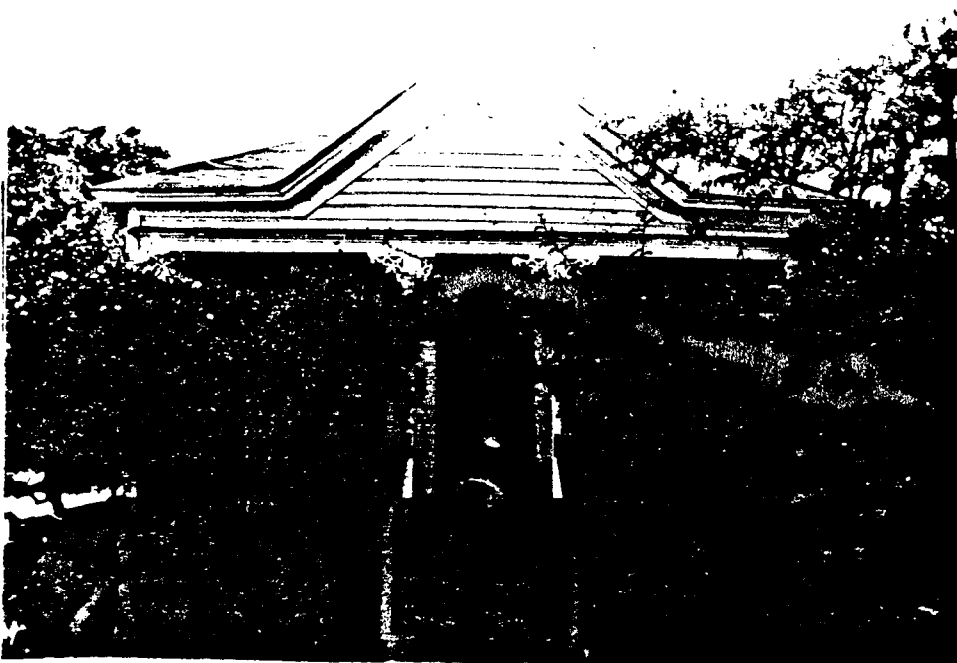
From the truncated hip roof of this pioneer style house there is a small gable that projects toward the street above the front entrance. This type house pre-dates the craftsman era by at least twenty years and the notable characteristics are the enclosed eaves and the frieze and the clapboard siding. The veranda porch features beveled columns with band sawn decorations used as support brackets which are located at the top of the columns where they meet the porch roof.

This early pioneer style house appears on city maps as early as 1906 and may well be over a hundred years old. The clapboard siding and the band-sower decorations on the porch columns were very stylish indeed at the time of its construction. The angled orientation of the house on its lot is significant in that it suggests that Egleberry Street was not always as straight as it is today.
