HISTORIC RESOURCES INVENTORY

1. Common name: _____
2. Historic name: _____
3. Street or rural address: 7766 Church Street
 City Gilroy Zip 95020 County Santa Clara
4. Parcel number: 79900344
5. Present Owner: Alberta Teague Address: 15876
 City Los Gatos Zip 95030 Ownership is: Public _____ Private X
6. Present Use: Residence Original use: Residence

Bungalow

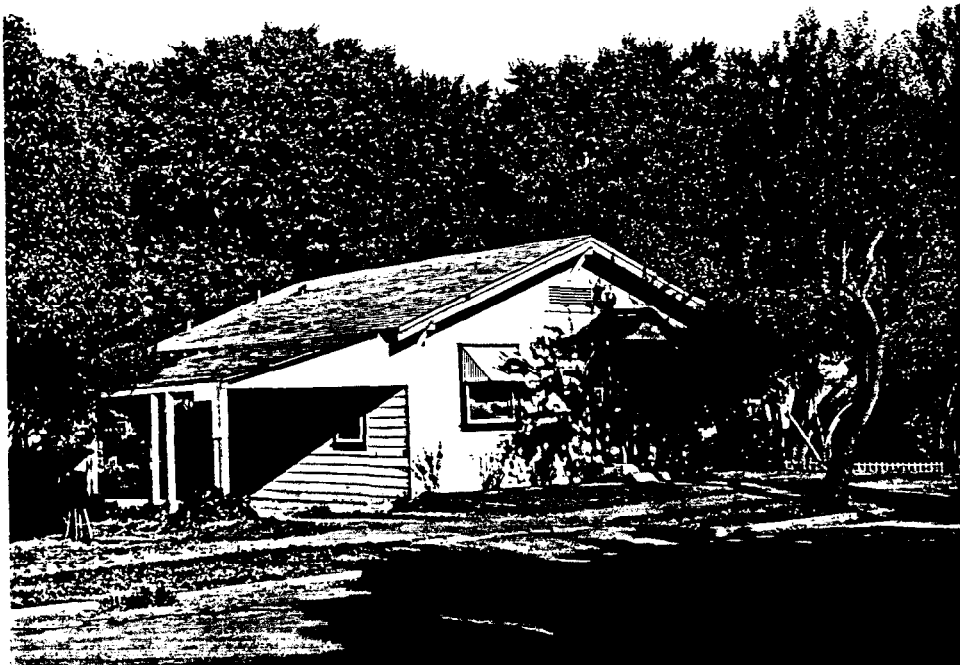
There is a medium gable roof on this somewhat dilapidated bungalow with exposed rafters and support brackets. It has wide clapboard siding and a small overhang above the front entrance. A carport has been added on the north side and the small metal awnings above the two front windows also appear to be new.

13. Condition: Excellent ___ Good ___ Fair ___X Deteriorated ___ No longer in existence ___
14. Alterations: Porch Extension
15. Surroundings: (Check more than one if necessary) Open land ___ Scattered buildings ___ Densely built-up X
Residential X Industrial ___ Commercial ___ Other: _____
16. Threats to site: None known X Private development ___ Zoning ___ Vandalism ___
Public Works project ___ Other: _____
17. Is the structure: On its original site? X Moved? ___ Unknown? ___
18. Related features: _____
