# HISTORIC RESOURCES INVENTORY

1. Common name: \_\_\_\_\_
2. Historic name: \_\_\_\_\_
3. Street or rural address: 338 West Seventh Street  
 City Gilroy Zip 95020 County Santa Clara
4. Parcel number: 79901525
5. Present Owner: Soledad Lerma Address: 338 W. Seventh St.  
 City Gilroy Zip 95020 Ownership is: Public \_\_\_\_\_ Private X
6. Present Use: Residence Original use: Residence

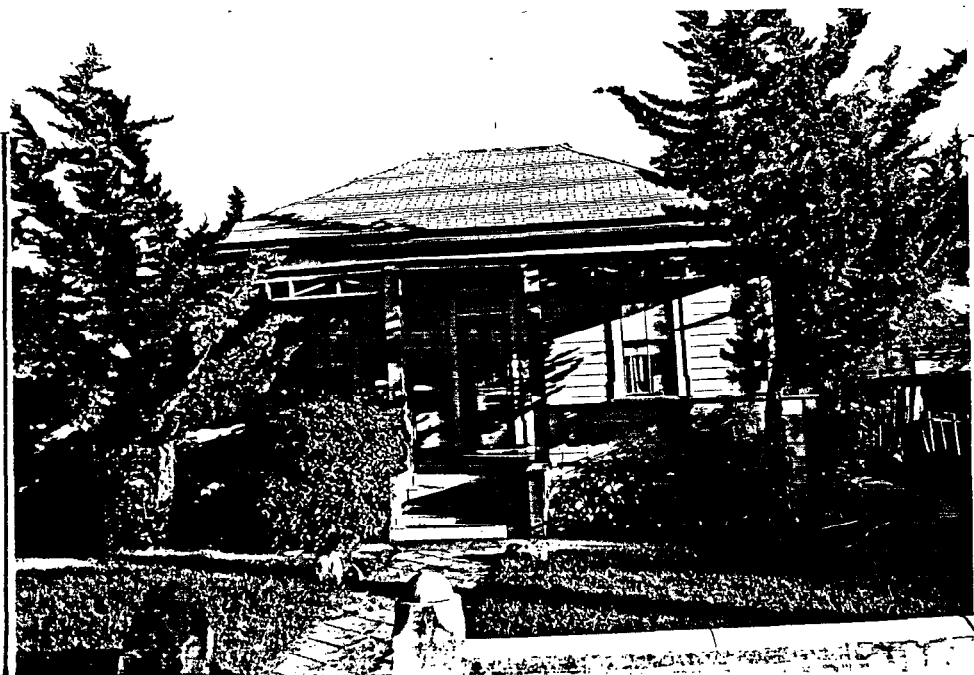
7653-5

A single story structure, rectangular in form with a hipped roof. A center entry door of three panels with transom is framed with a decorative surround. The two front windows have the same detail. Below the wide overhanging boxed eaves is a plain frieze. The porch is recessed under the main roof and is supported by four square posts. Th structure is raised 6 steps. Sheathing is horizontal board in flush joint style. The porch has a decorative stich screen just below the frieze.

13. Condition: Excellent \_\_\_ Good A Fair \_\_\_ Deteriorated \_\_\_ No longer in existence \_\_\_
14. Alterations: \_\_\_\_\_
15. Surroundings: (Check more than one if necessary) Open land \_\_\_ Scattered buildings \_\_\_ Densely built-up X  
Residential X Industrial \_\_\_ Commercial \_\_\_ Other: \_\_\_\_\_
16. Threats to site: None known X Private development \_\_\_ Zoning \_\_\_ Vandalism \_\_\_  
Public Works project \_\_\_ Other: \_\_\_\_\_
17. Is the structure: On its original site? X Moved? \_\_\_ Unknown? \_\_\_
18. Related features: Mature landscaping
