HISTORIC RESOURCES INVENTORY

1. Common name: _____
2. Historic name: _____
3. Street or rural address: 7441 Monterey Street
 City Gilroy Zip 95020 County Santa Clara
4. Parcel number: 79900757
5. Present Owner: Miguel Gaeta Address: 7320 Princevalle S
 City Gilroy Zip 95020 Ownership is: Public _____ Private X
6. Present Use: _____ store Original use: _____

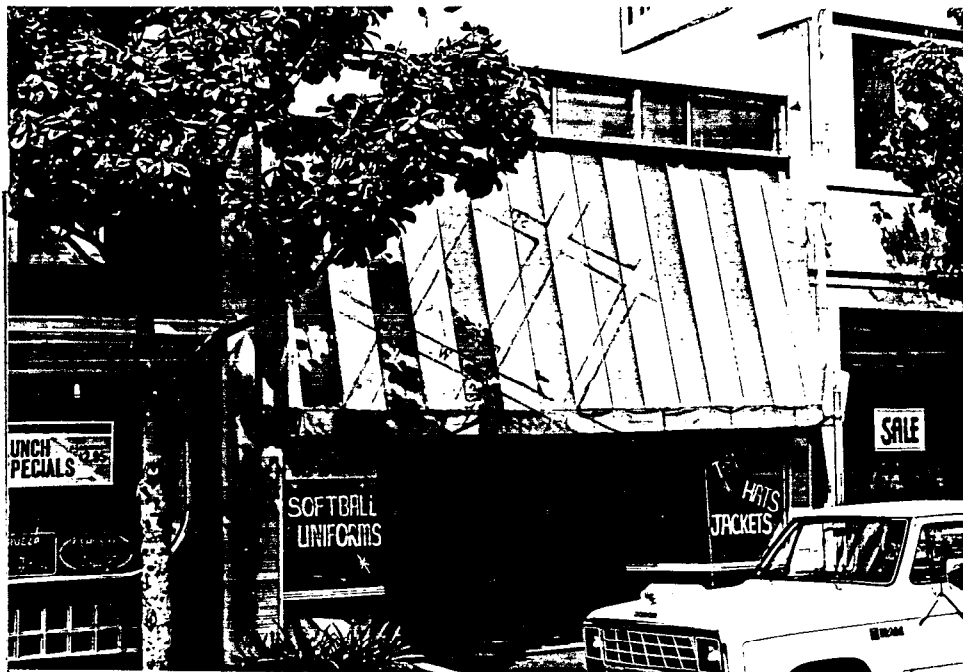
A large awning obscures most of the facade of this one story rectangular structure. The facade is primarily display windows slanted to a deeply recessed entrance. One of the longer structures on this block it has a correspondingly long display area before the entrance door. The structure appears to have been remodeled in the 40's-50's, but retains the basic form important to the overall integrity of downtown Gilroy.

13. Condition: Excellent ___ Good Fair ___ Deteriorated ___ No longer in existence ___
14. Alterations: Storefront
15. Surroundings: (Check more than one if necessary) Open land ___ Scattered buildings ___ Densely built-up
Residential ___ Industrial ___ Commercial Other: _____
16. Threats to site: None known Private development ___ Zoning ___ Vandalism ___
Public Works project ___ Other: _____
17. Is the structure: On its original site? Moved? ___ Unknown? ___
18. Related features: _____

7441 Monterey is another case of the correct size and form for the downtown, however, its contribution may be enhanced by less awning and more architectural understanding. The significance of this structure is as a component in the total downtown concept. This was for many years the Cimino Brothers Shoe store, and later became Montgomery Wards catalogue store.
