HISTORIC RESOURCES INVENTORY

1. Common name: Gilroy Hardware
2. Historic name: _____
3. Street or rural address: 7445 Monterey Street
 City Gilroy Zip 95020 County Santa Clara
4. Parcel number: 79900756
5. Present Owner: Ralph Blackburn Address: 7445 Monterey Street
 City Gilroy Zip 95020 Ownership is: Public _____ Private X
6. Present Use: Hardware Store Original use: commercial

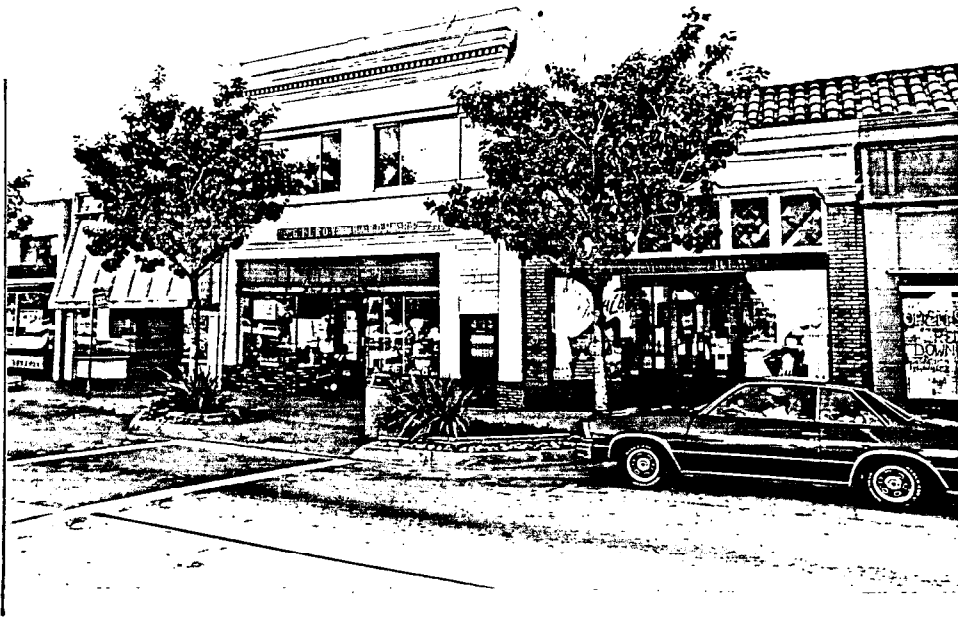
This two story commercial structure has a flat roof, is rectangular in form and maintains its over all architectrual integrity. The storefront starts with the addition of used brick to define the display windows and recessed entry. Above the display panes is a band of small square panes that have been painted over. The frame of the commercial front is set below a molded band of sting coursing. The upper horizontal massing contains two windows, with modified frames, a plain band and an ornate, by Gilroy standards, classical cornice. This projecting cornice is composed of multiple layers of horizontal bands with dentils and additional moldings. The classic detail of an attic space completes the facade. An alteration to the entrance to the upstairs is an infill of painted shingles.

13. Condition: Excellent ___ Good X Fair ___ Deteriorated ___ No longer in existence ___
14. Alterations: Storefront windows
15. Surroundings: (Check more than one if necessary) Open land ___ Scattered buildings ___ Densely built-up X
Residential ___ Industrial ___ Commercial X Other: _____
16. Threats to site: None known X Private development ___ Zoning ___ Vandalism ___
Public Works project ___ Other: _____
17. Is the structure: On its original site? X Moved? ___ Unknown? ___
18. Related features: _____
