HISTORIC RESOURCES INVENTORY

1. Common name: J. C. Penney
2. Historic name: _____
3. Street or rural address: 7526 Monterey Street
 City Gilroy Zip 95020 County Santa Clara
4. Parcel number: 84105056
5. Present Owner: Unknown Address: _____
 City _____ Zip _____ Ownership is: Public _____ Private _____
6. Present Use: Retail/Commercial Original use: Retail/Commercial

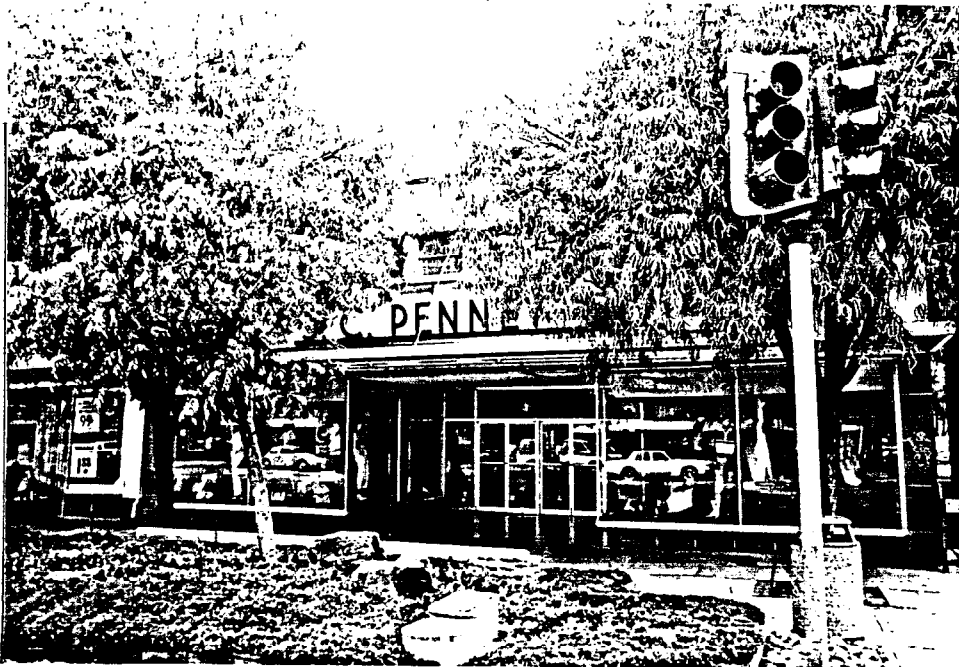
One of the wider facades on Monterey Street, this is also one of the later structures to be constructed. A two story structure divided horizontally between the full width storefront and the fenestration and cover of administrative space. The storefront has a squared recess to the double set of metal frame entry doors. The remainder is large plates of glass. The upper floor is a geometric pattern of ridges and fenestration.
