HISTORIC RESOURCES INVENTORY

1. Common name: \_\_\_\_\_
2. Historic name: \_\_\_\_\_
3. Street or rural address: 7531 Alexander Street  
City Gilroy Zip 95020 County Santa Clara
4. Parcel number: 84100540
5. Present Owner: David Nunez Address: 7531 Alexander Street  
City Gilroy Zip 95020 Ownership is: Public \_\_\_\_\_ Private X
6. Present Use: Residence Original use: Residence

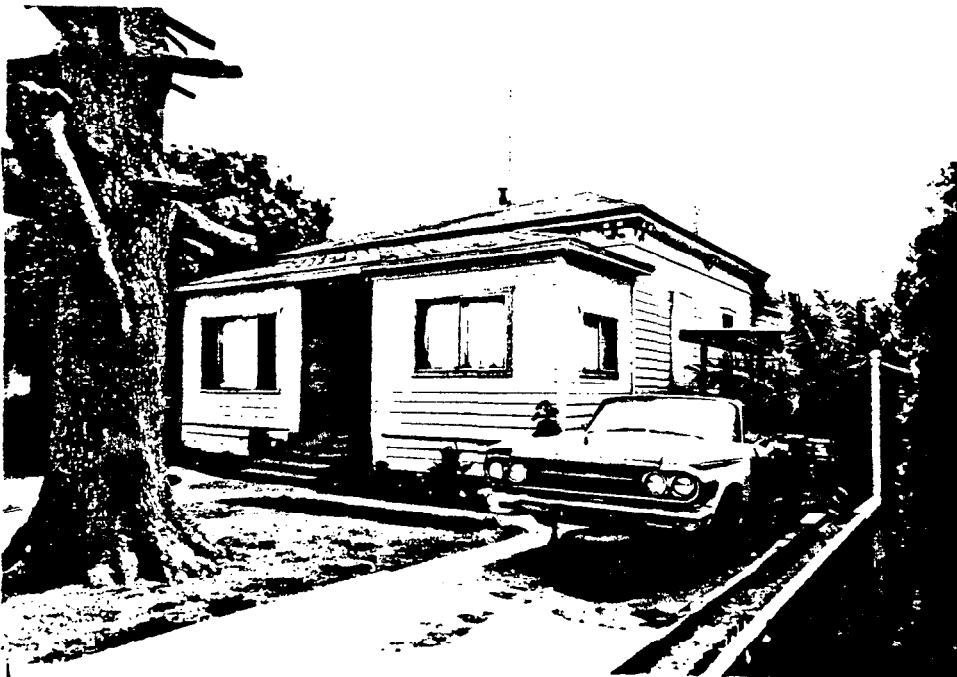
8678-9

Originally a square form, single story structure with a hipped roof. The original structure has wide boxed eaves with paired brackets typical of Italianate design. Wide horizontal board siding sheathes the structure. Two original window frames with classic crown and flat surround are on each side. Additions are in the rear that is minor, have obliterated the architectural integrity of this structure. Two large projecting wings have been added to the front. This addition, connected by a common roofline has aluminum frame windows of different sizes.
