HISTORIC RESOURCES INVENTORY

1. Common name: \_\_\_\_\_
2. Historic name: Montgomery Ward Building
3. Street or rural address: 7542 Monterey  
 City Gilroy Zip 95020 County Santa Clara
4. Parcel number: 84100557
5. Present Owner: Unknown Address: \_\_\_\_\_  
 City \_\_\_\_\_ Zip \_\_\_\_\_ Ownership is: Public \_\_\_\_\_ Private \_\_\_\_\_
6. Present Use: Commercial Original use: commercial

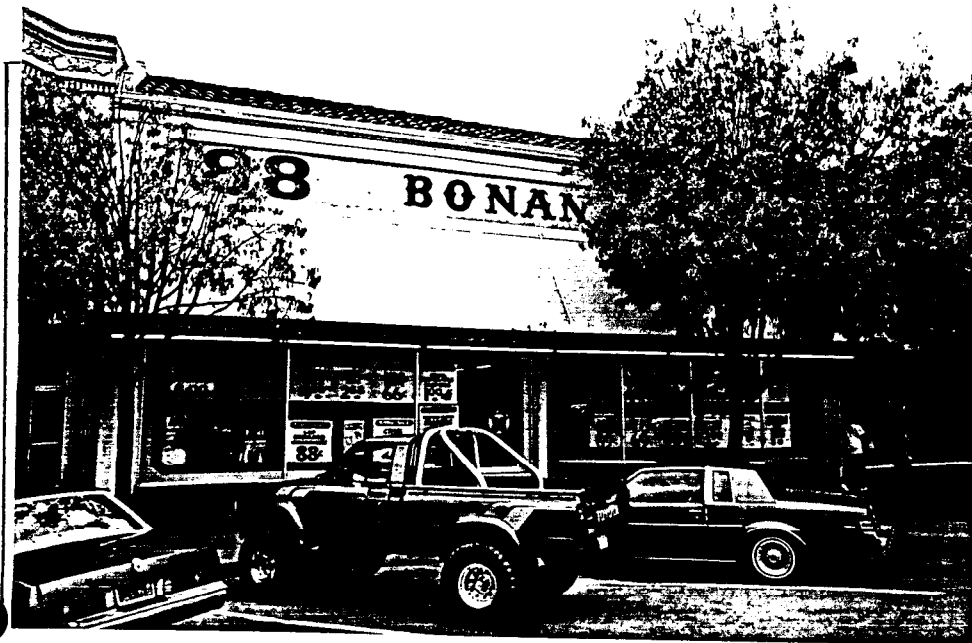
The site consists of a two story stucco and tile building constructed on a rectangular plan and designed in a stripped Spanish Colonial revival style. The building exhibits very minimal detailing with a simple molded cornice line and a large horizontal incised panel providing the upper story its only ornament. An extended metal awning separates the second and first floors and is supported by long metal cables. The street front itself is very simple with large plate glass windows and aluminum framed double doors. The building is another example of a downtown building which is less significant as an individual piece of architecture, but which exhibits the siting, massing, building height and breakup of space on the street facade that reinforces the urban design qualities of Gilroy's central business district.

13. Condition: Excellent \_\_\_ Good  Fair \_\_\_ Deteriorated \_\_\_ No longer in existence \_\_\_
14. Alterations: facade cover
15. Surroundings: (Check more than one if necessary) Open land \_\_\_ Scattered buildings \_\_\_ Densely built-up   
Residential \_\_\_ Industrial \_\_\_ Commercial  Other: \_\_\_
16. Threats to site: None known  Private development \_\_\_ Zoning \_\_\_ Vandalism \_\_\_  
Public Works project \_\_\_ Other: \_\_\_
17. Is the structure: On its original site?  Moved? \_\_\_ Unknown? \_\_\_
18. Related features: \_\_\_
