HISTORIC RESOURCES INVENTORY

1. Common name: \_\_\_\_\_
2. Historic name: \_\_\_\_\_
3. Street or rural address: 7550 Monterey Street  
 City Gilroy Zip 95020 County Santa Clara
4. Parcel number: 84100558
5. Present Owner: Andrew Battagin Address: P.O. Box 95  
 City Gilroy Zip 95020 Ownership is: Public \_\_\_\_\_ Private X
6. Present Use: Clothing Store Original use: Commercial

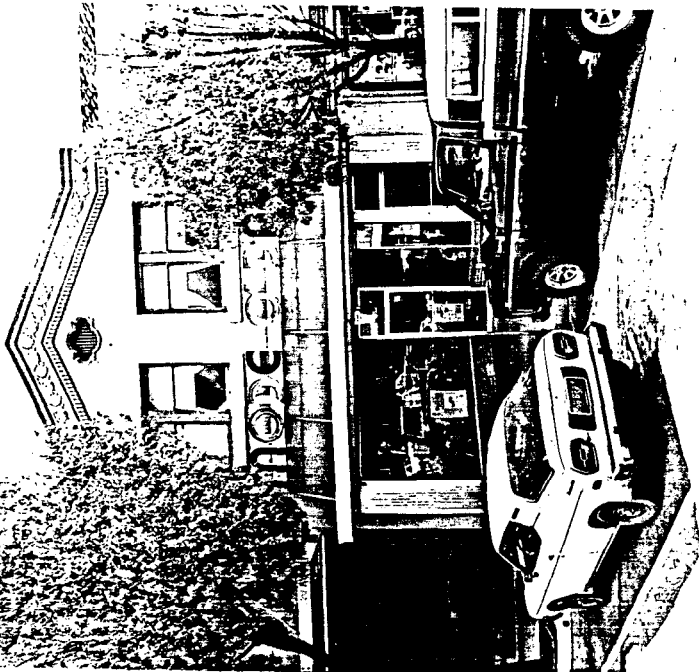
- 7a. Architectural style: Spanish Colonial Revival
- 7b. Briefly describe the present *physical appearance* of the site or structure and describe any major alterations from its original condition:  
 A two story structure of rectangular form constructed of brick with stucco sheathing. The facade is divided above the first floor storefront by the suspended metal awning. The storefront and entry to the upper floor have been remodeled to a commercial aluminum frame and window. A low base carries the angle recess to the entry complete this section. The fenestration, a row of opaque windows immediately above the awning have been covered over. A stylized sign of independent letters crosses the structure. The second floor facade has two paired windows in simple frames of wood sash. The character of the structure is in the peaked cornice line ornamented with moldings relief and a projecting bored cornice. Centered below the peak is a foil in Spanish style. Although the entire facade has been remodeled from the 1800's design, the work probably dates from the 1920's and is one of the distinctive facades on Monterey Street.

13. Condition: Excellent \_\_\_ Good X Fair \_\_\_ Deteriorated \_\_\_ No longer in existence \_\_\_
14. Alterations: facade
15. Surroundings: (Check more than one if necessary) Open land \_\_\_ Scattered buildings \_\_\_ Densely built-up X  
Residential \_\_\_ Industrial \_\_\_ Commercial X Other: \_\_\_
16. Threats to site: None known X Private development \_\_\_ Zoning \_\_\_ Vandalism \_\_\_  
Public Works project \_\_\_ Other: \_\_\_
17. Is the structure: On its original site? X Moved? \_\_\_ Unknown? \_\_\_
18. Related features: \_\_\_
