HISTORIC RESOURCES INVENTORY

- 1. Common name: _____
- 2. Historic name: _____
- 3. Street or rural address: 7831 Hanna Street
City Gilroy Zip 95020 County Santa Clara
- 4. Parcel number: 79902007
- 5. Present Owner: Michael J. Ransom Address: 7831 Hanna Street
City Gilroy Zip 95020 Ownership is: Public _____ Private X
- 6. Present Use: Residence Original use: Residence

- 7a. Architectural style: Bungalow
- 7b. Briefly describe the present physical appearance of the site or structure and describe any major alterations from its original condition:

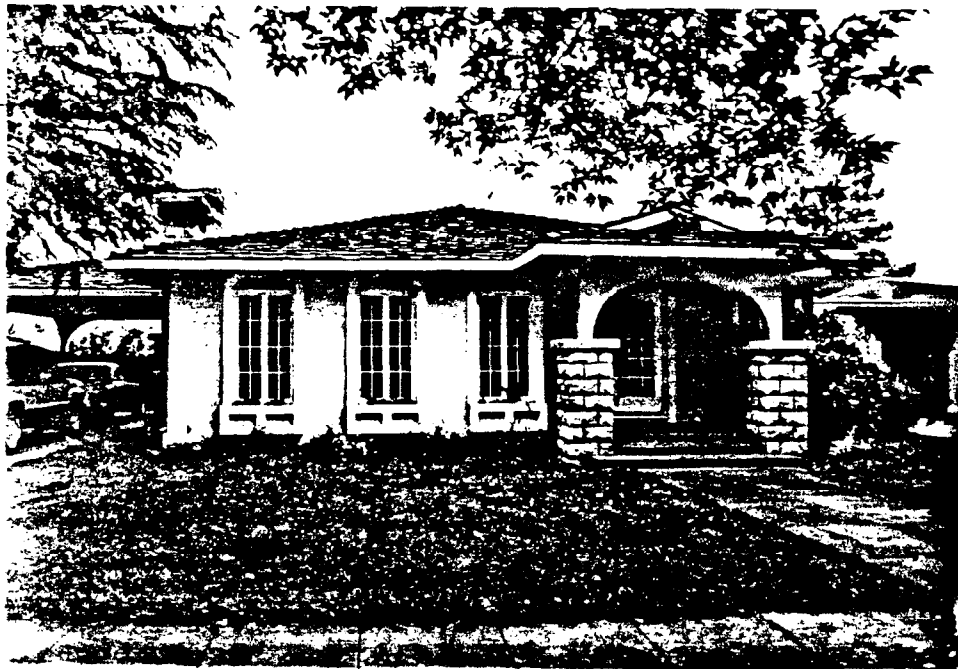
This stucco bungalow has a low hipped roof and an unusual hipped pediment above the small portico porch. The many curved lines used in the design of the house give it a very unique, quaint feeling. The entryway is arched, a style which is repeated in the raised decoration around the french sash windows which are also decorated with window boxes for flowers. There are stone block pillars supporting the front portico and in the driveway under the trellis.
